# MONUMENT RECORD

Corner ID: **BeBI\_G13**

## Quarter Corner

Sections 17 & 20- T10N-R02W, 2nd P.M.  
Bean Blossom Township, Monroe County,  
Indiana

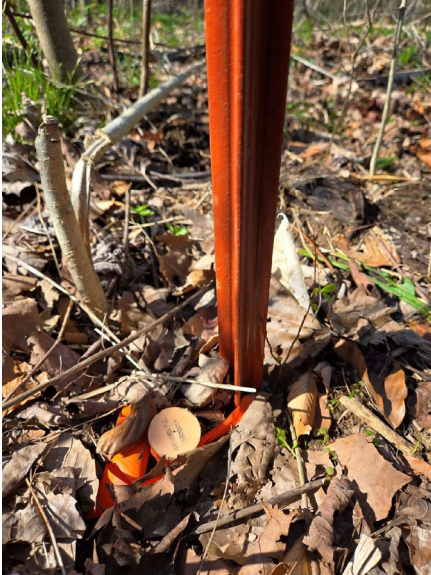
Photo Orientation & Description: From above

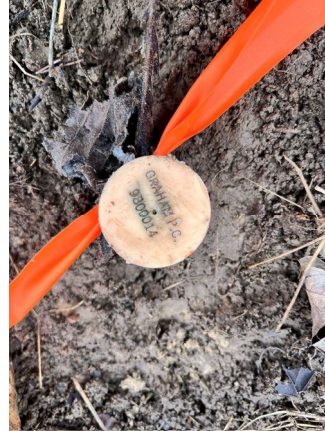
Photo Orientation & Description: From above
